# Manhole Inspection Summary

## Manhole # S21GG\_017MH

**Location** Address: **1528 PRESSER CT**

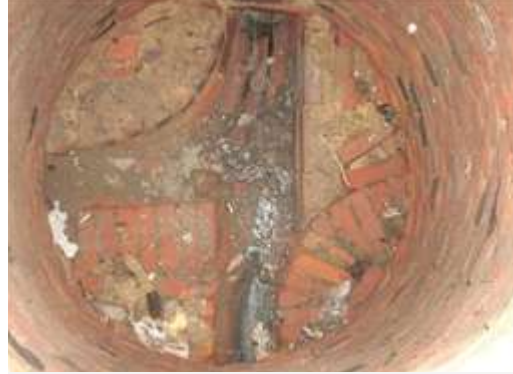
Top View

DEBRIS ON BENCH

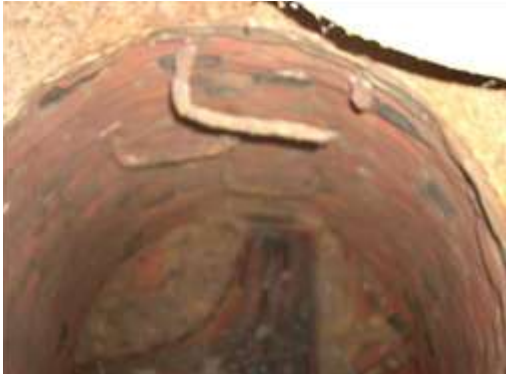
Defect 1

**Steps** Count: **2** Missing: **1** ☒ **Corroded**

MISSING AND CORRODED STEPS

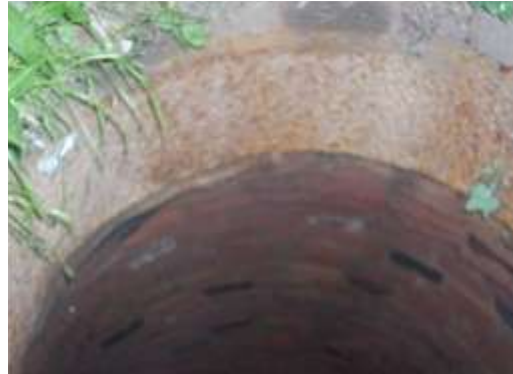
Defect 2

Condition: ☐ Sound ☐ Cracked ☐ Root Intrusion ☐ Loose Brick ☒ **Deteriorated**

CHIMNEY DETERIORATION

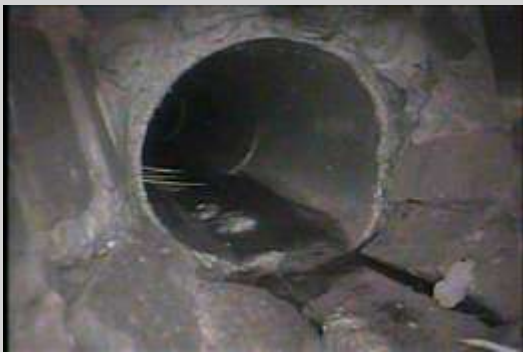
12 O'Clock Outflow

DEBRIS IN CHANNEL

Pipe Height: **8.4** (in.) Rod and Bar (Angled)  
Pipe Material: **Clay** ☐ Pipe Lined  
Invert Depth: **7.34** (ft.) Flow Characteristics: **Slow**  
Deposits: ☐ None ☐ **Mud** ☐ Sludge ☒ **Debris** ☐ Grease  
Silt Depth: **1** (in.) Deposits Extent: **Light**  
Infiltration: **None** Pipe Seal Cond: **Sound**

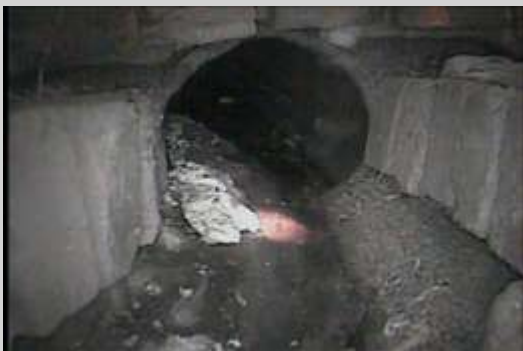
6 O'Clock Inflow

DEBRIS IN CHANNEL

Pipe Height: **8.4** (in.) Rod and Bar (Angled)  
Pipe Material: **Clay** ☐ Pipe Lined  
Invert Depth: **7.12** (ft.) Flow Characteristics: **Slow**  
Deposits: ☐ None ☐ **Mud** ☐ Sludge ☒ **Debris** ☐ Grease  
Silt Depth: **3** (in.) Deposits Extent: **Medium**  
Infiltration: **None** Pipe Seal Cond: **Sound**

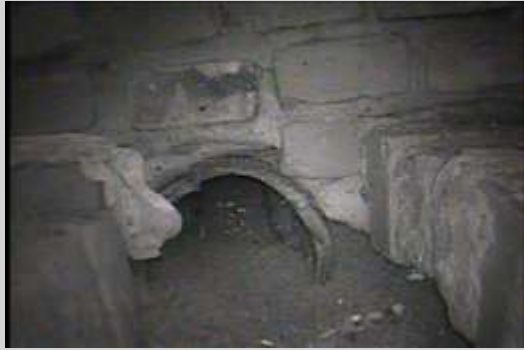
9 O'Clock Inflow

Deposits: ☐ None ☒ **Mud** ☐ Sludge ☐ Debris ☐ Grease

Silt Depth: **4** (in.) Deposits Extent: **Medium**
